# Grizzly Creek Fire and City of Glenwood Springs Raw/Treated Water Projects

**Matthew Langhorst, Director of Public Works - Glenwood Springs**

**Leanne Miller – Carollo Engineering**

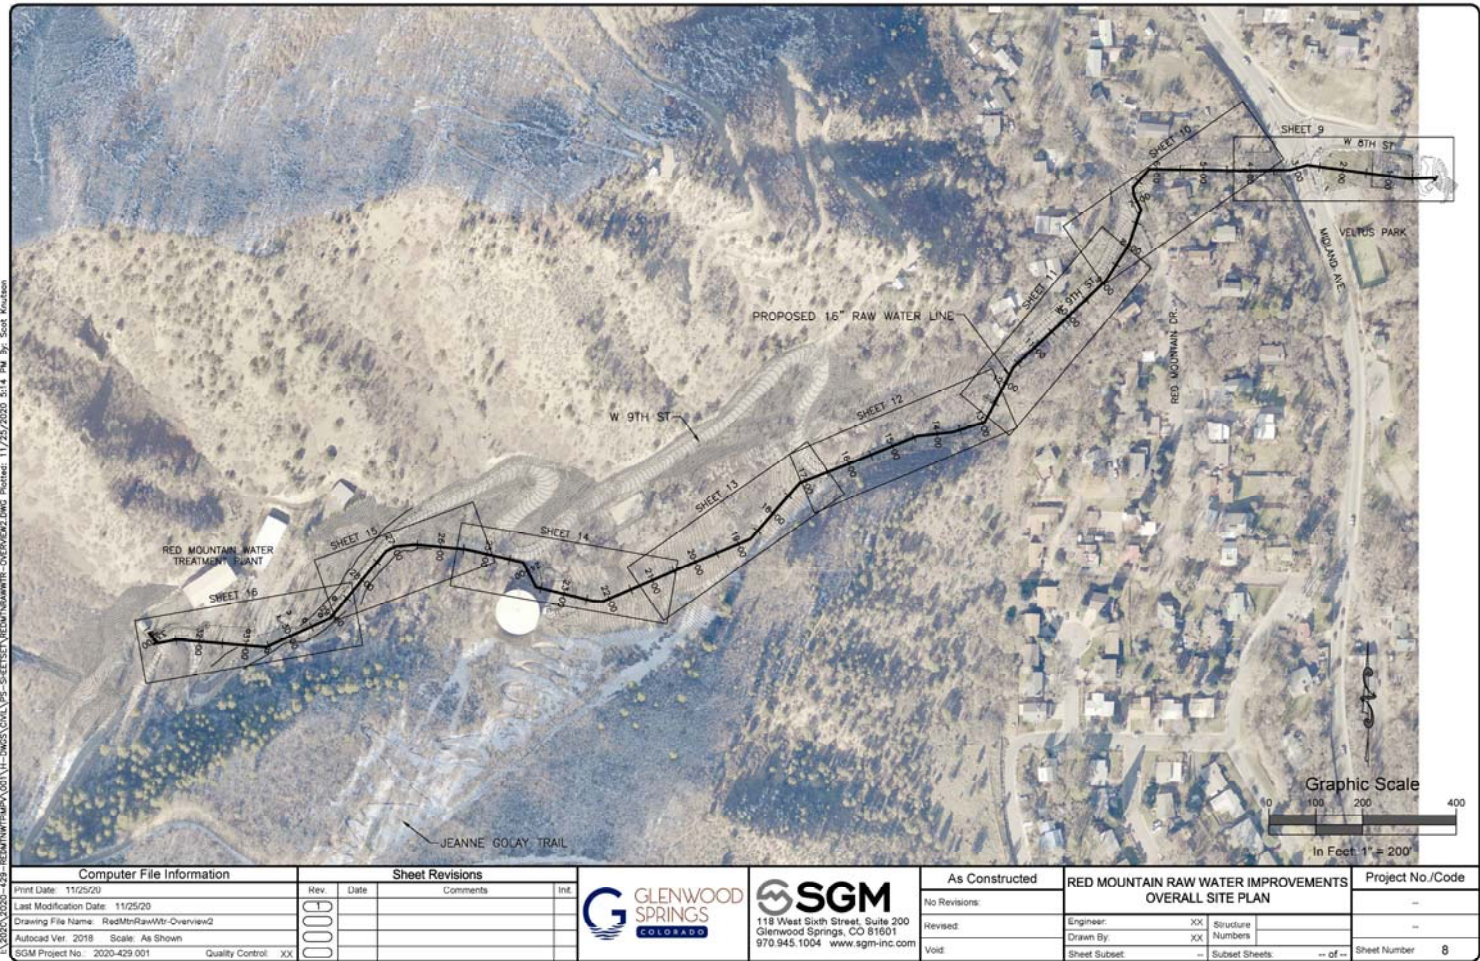
# Phase 4 – 3,316LF of 16" DIP and Mixing Vault

## Phase Four (2021-22): Raw Water Line from Roaring Fork River Pump Station to the Red Mtn WTP

1.) Achieves a truly redundant third water source. The Roaring Fork Pump Station was designed and built to complete pipe, tank and intake construction in 1997 and to be used as an emergency backup.

2.) Variable speed pump upgrades will allow delivery of range of Roaring Fork River water flows up to 5 MGD to the Red Mtn WTP.

3.) Mixing vault near WTP will allow blending of pumped River water and gravity-fed Creek water. Improves operational flexibility to manage water quantity and quality during drought and/or degraded raw water quality conditions.

4.) New line provides redundancy to allow maintenance of 44-year-old, 24" raw waterline. Old line can be off-line for inspection, addition of new valve or review of the raw water pipe bridge. Currently, this is nearly impossible to accomplish.
